FLIGHT TESTS OF VARIOUS TAIL MODIFICATIONS

ON THE BREWSTER XSBA-1 AIRPLANE

I - MEASUREMENTS OF FLYING QUALITIES

WITH ORIGINAL TAIL SURFACES

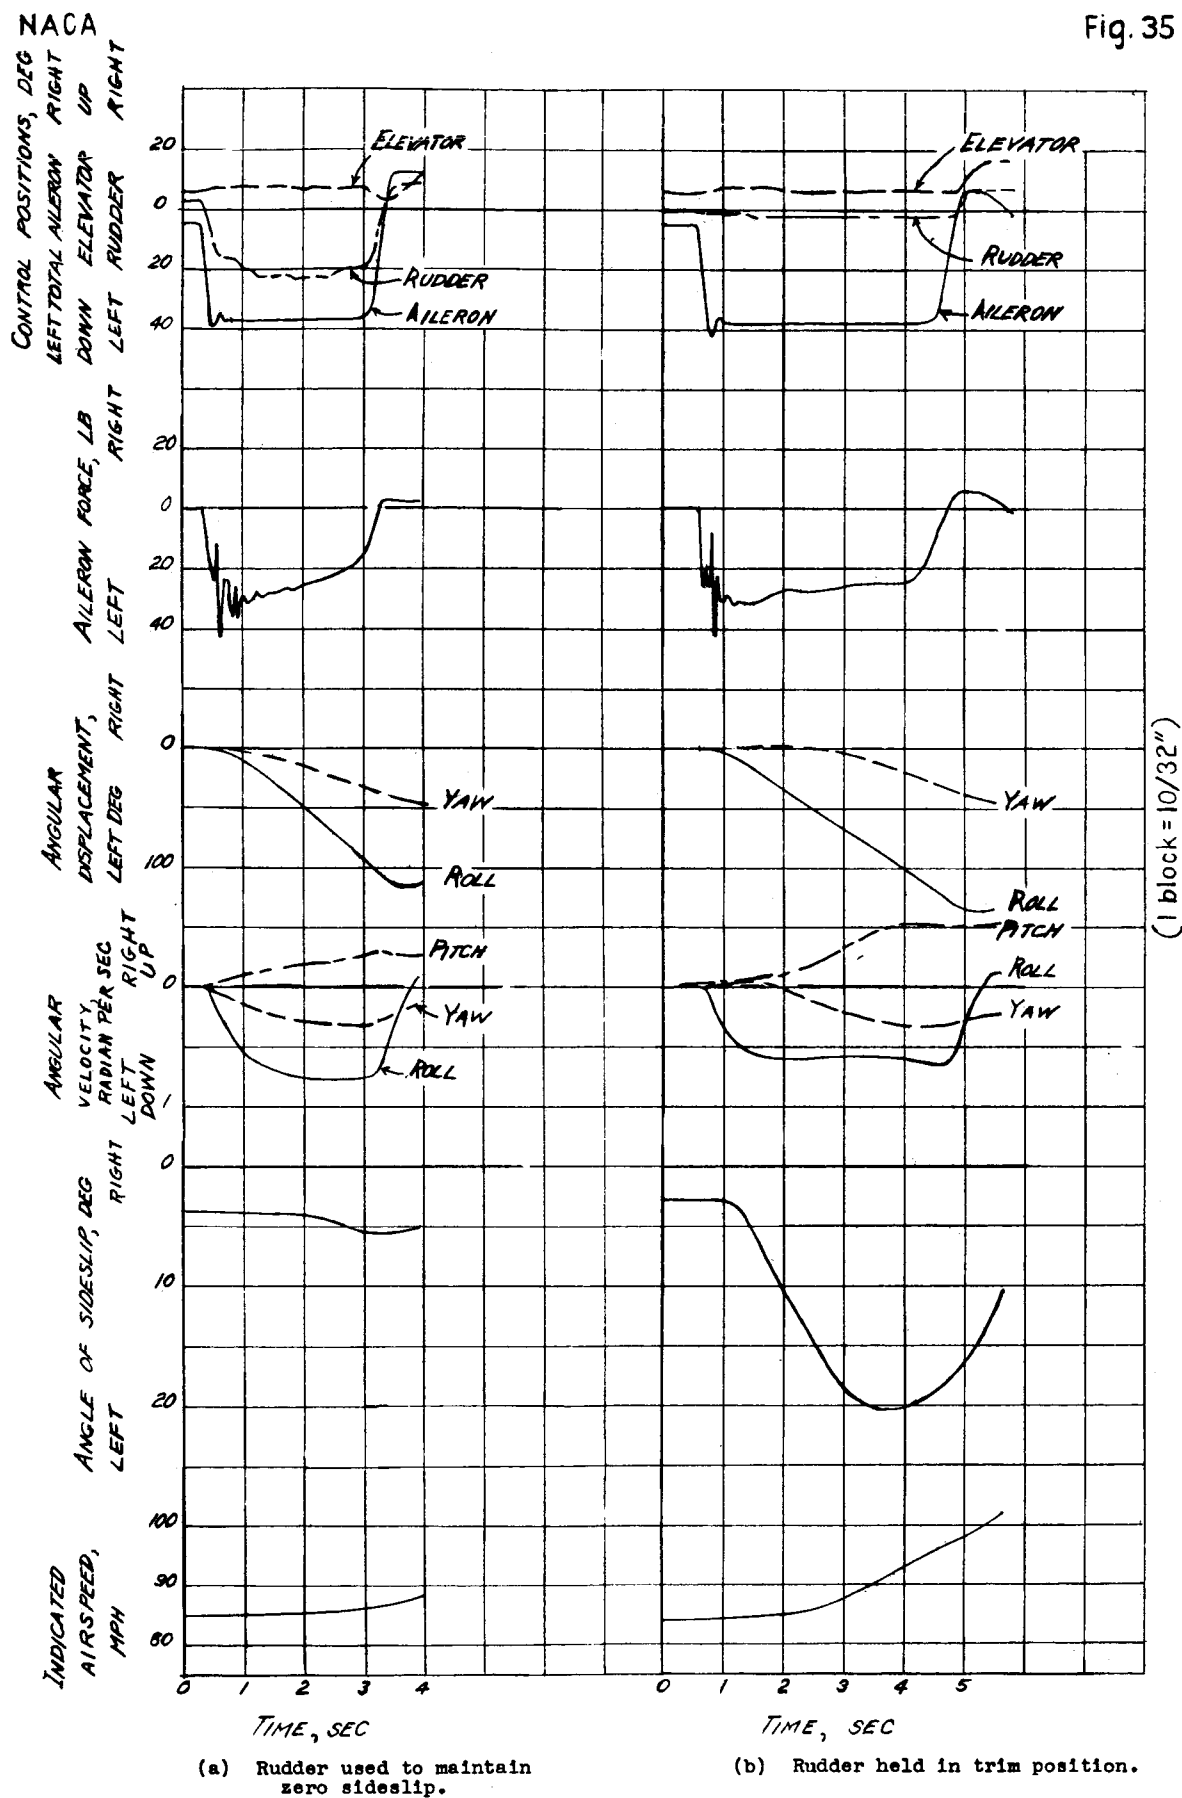
(a) Rudder used to maintain zero sideslip.

(b) Rudder held in trim position.

Figure 35. - Time histories of aileron rolls made in the landing condition.

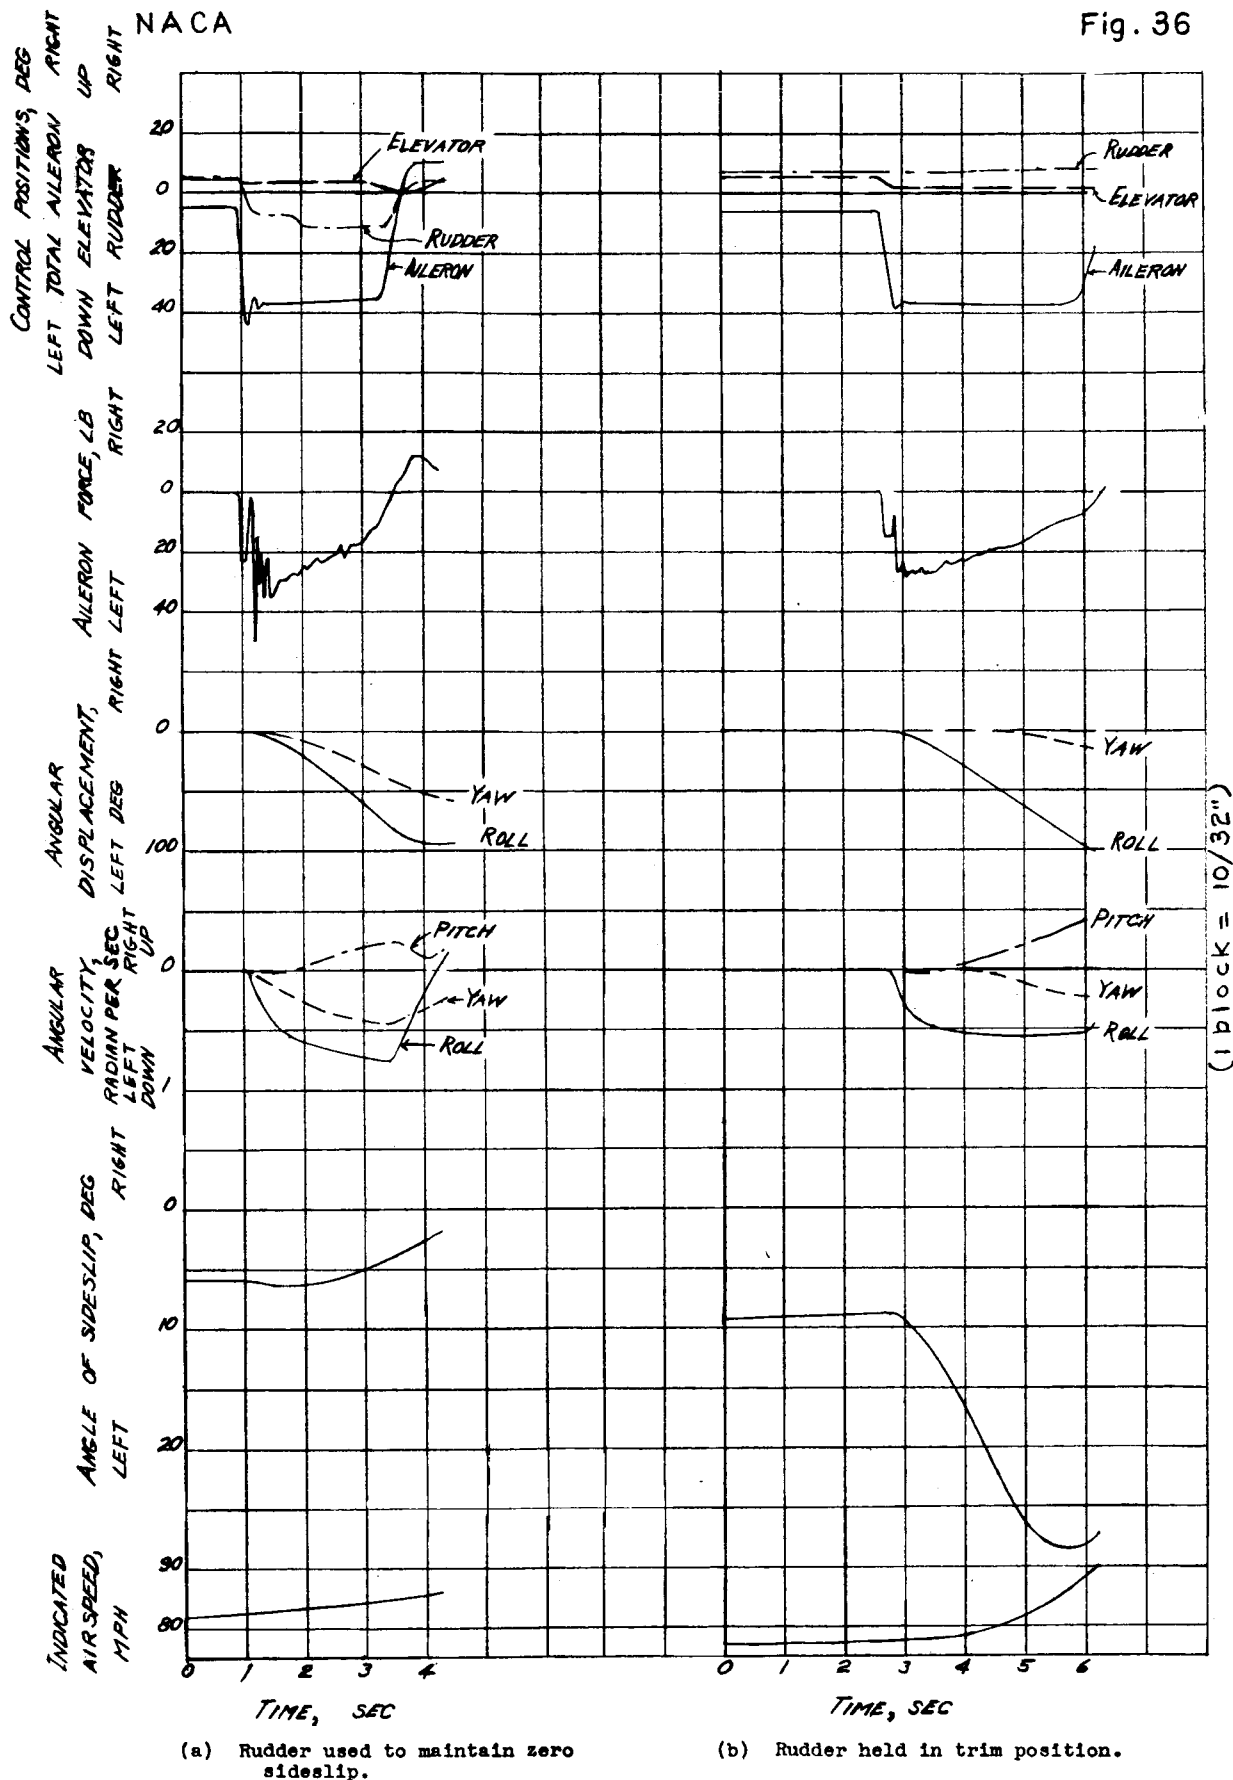
Figure 36. - Time histories of aileron rolls made in the cruising condition.

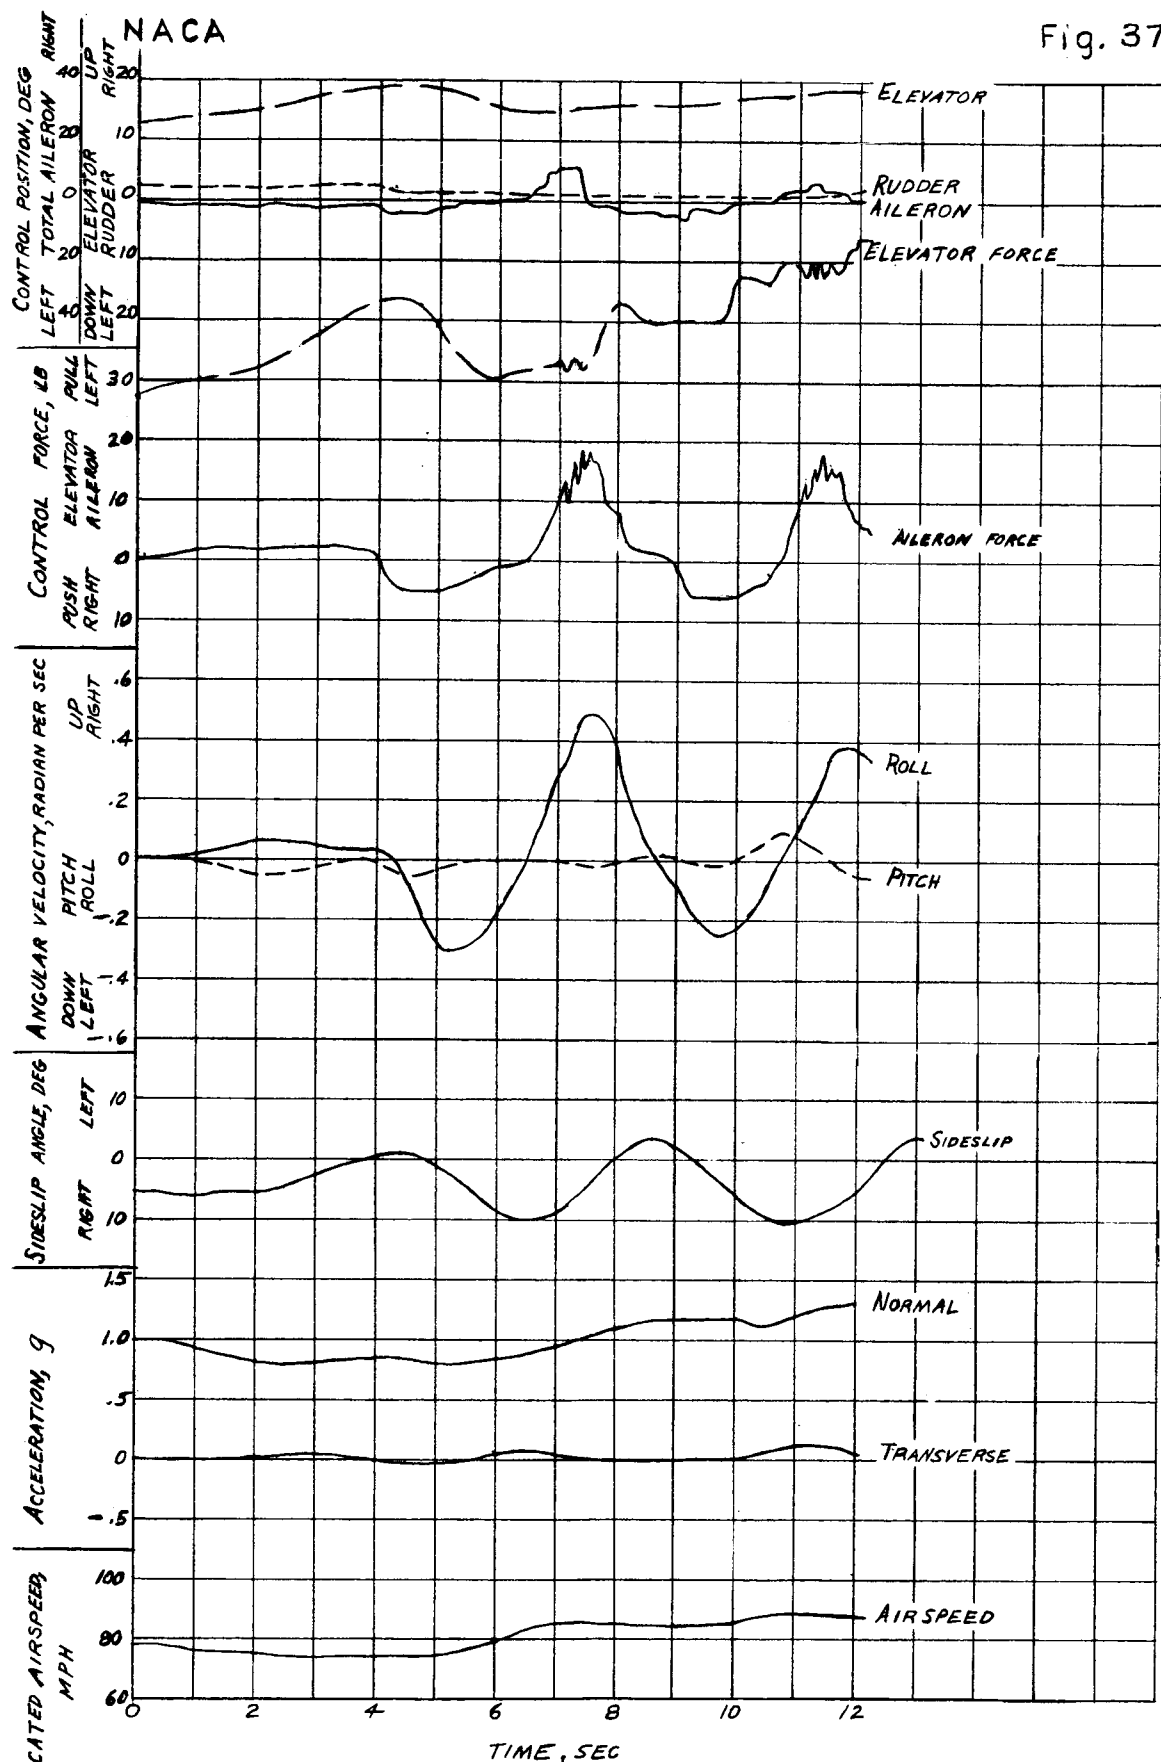
Figure 37. - Time history of a stall in gliding condition (flaps up, gear up, power off) with controls held fixed. Airplane performs rolling oscillation of constant amplitude. Brewster XSBA-1 airplane.

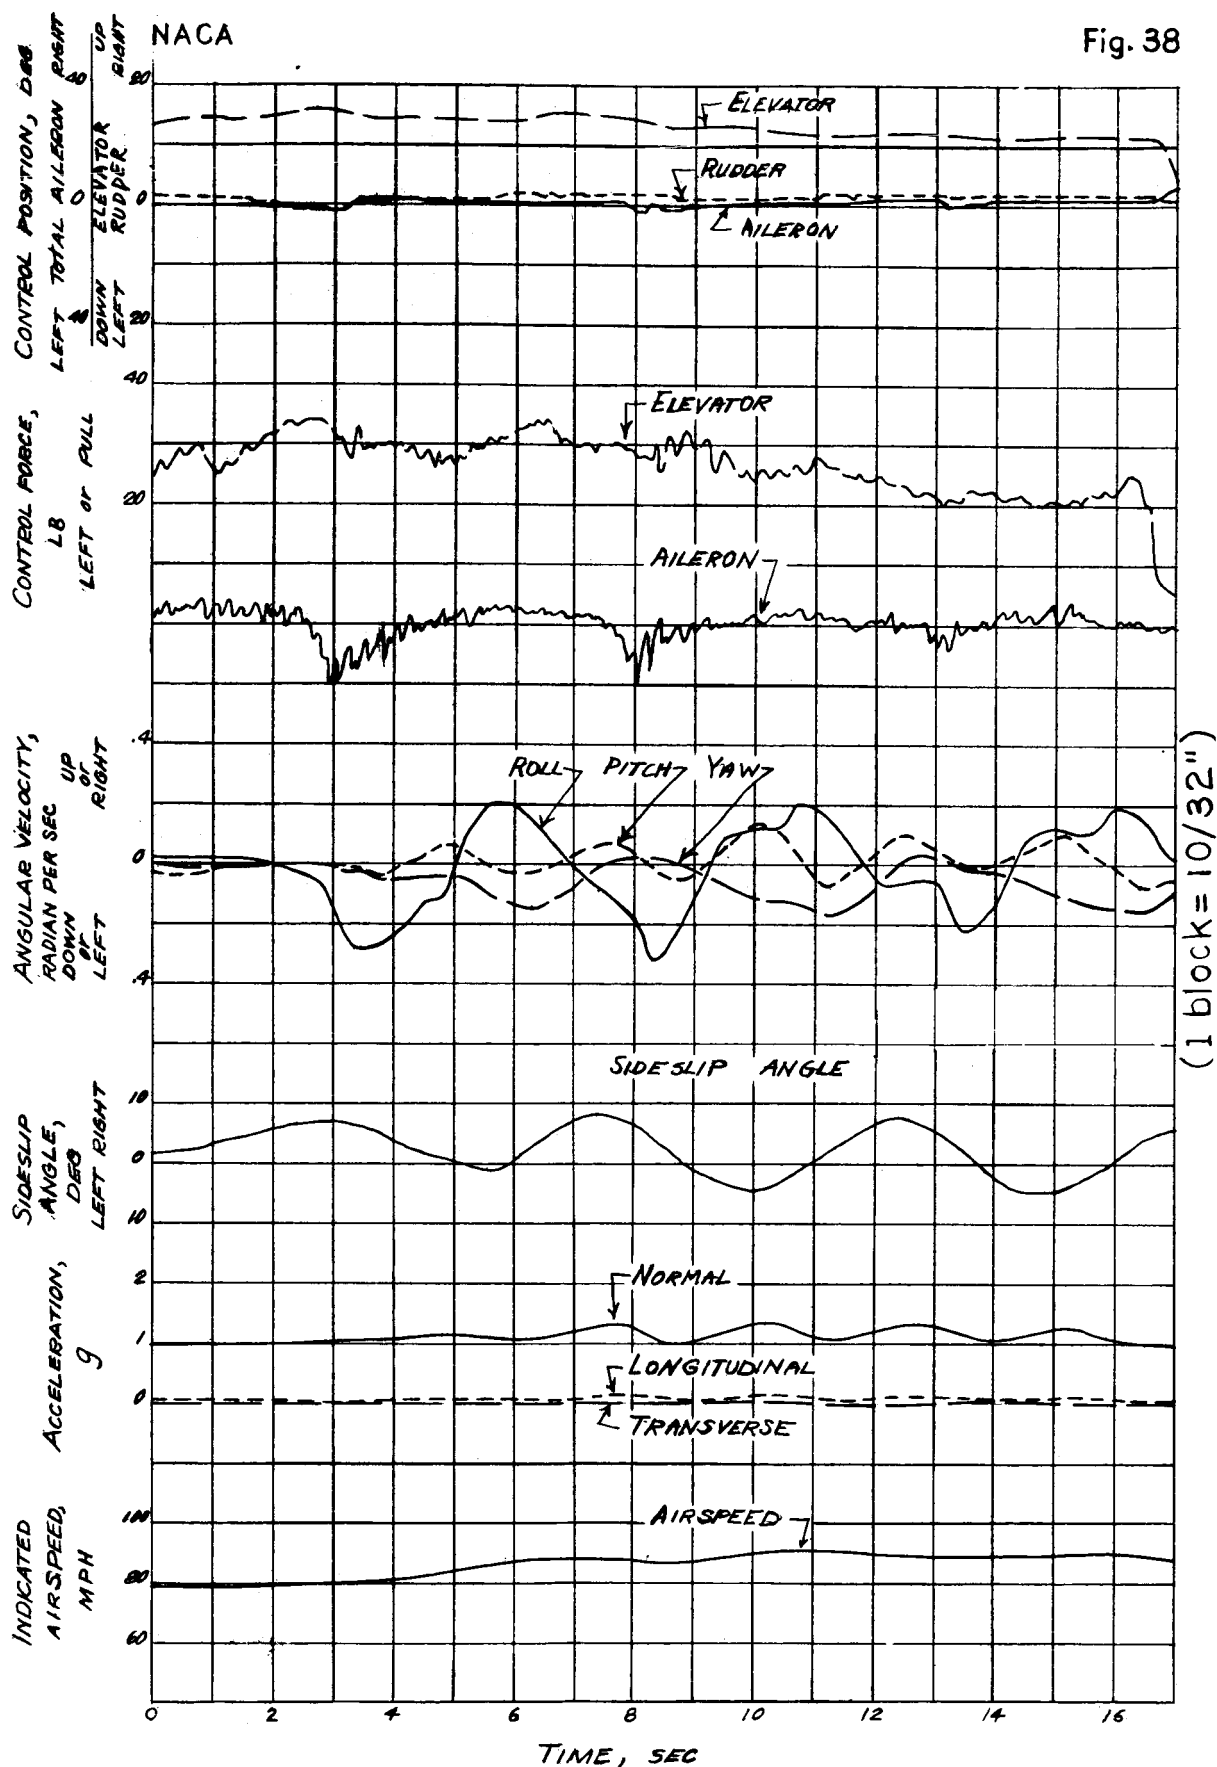
Figure 38. - Time history of a stall in gliding condition (flaps up, gear up, power off) holding controls fixed. Note complicated rolling and pitching oscillation of constant amplitude. Pitching oscillation has twice frequency of rolling oscillation. Brewster XSBA-1 airplane.

The results of these tests are presented in the form of time histories (figs. 37 to 48). The conclusions reached are as follows:

11. The stalling characteristics were good. Adequate stall warning existed in all conditions of flight in the form of pitching and rolling motions of the airplane. Control of the airplane in a partly stalled condition could be

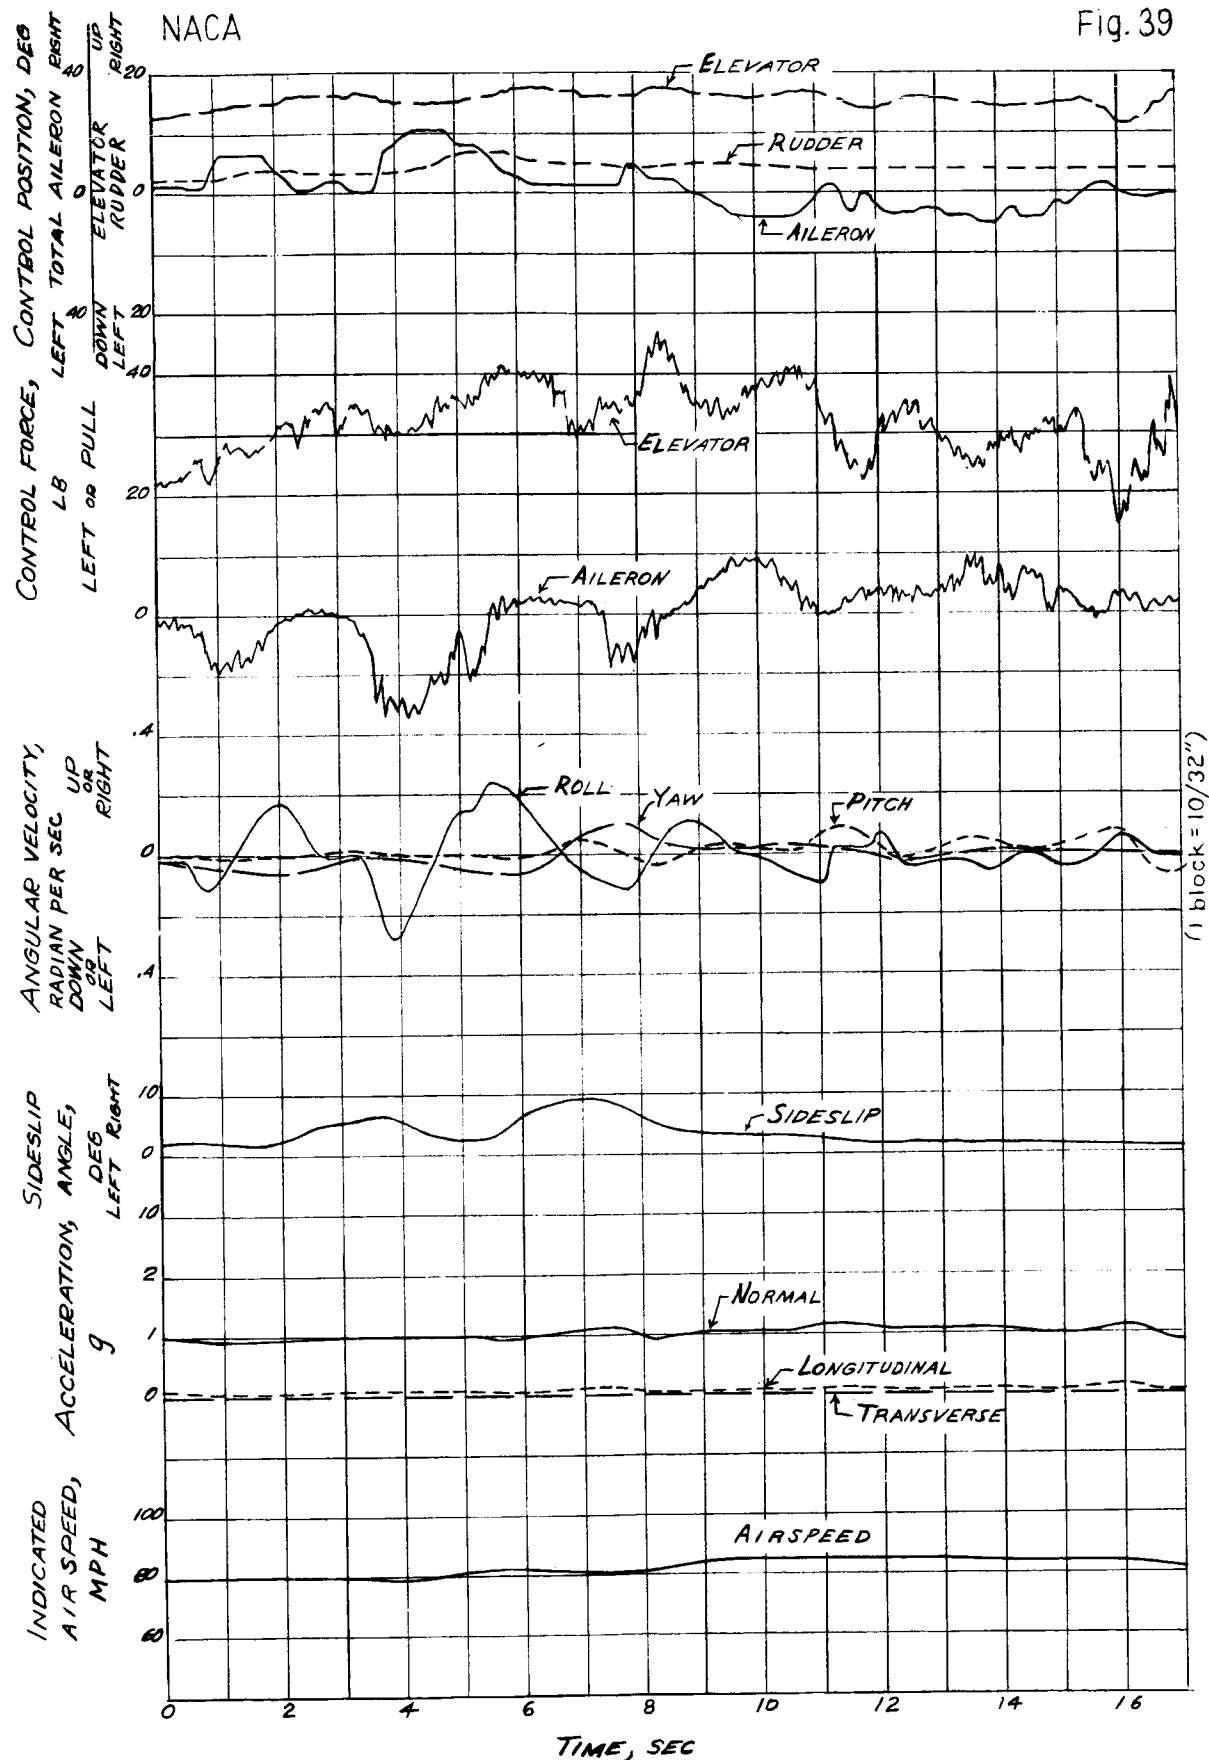
Figure 39. - Time history of a stall in the gliding condition (flaps up, gear up, power off)
Control is maintained by use of the ailerons. Brewster XSBA-1 airplane.

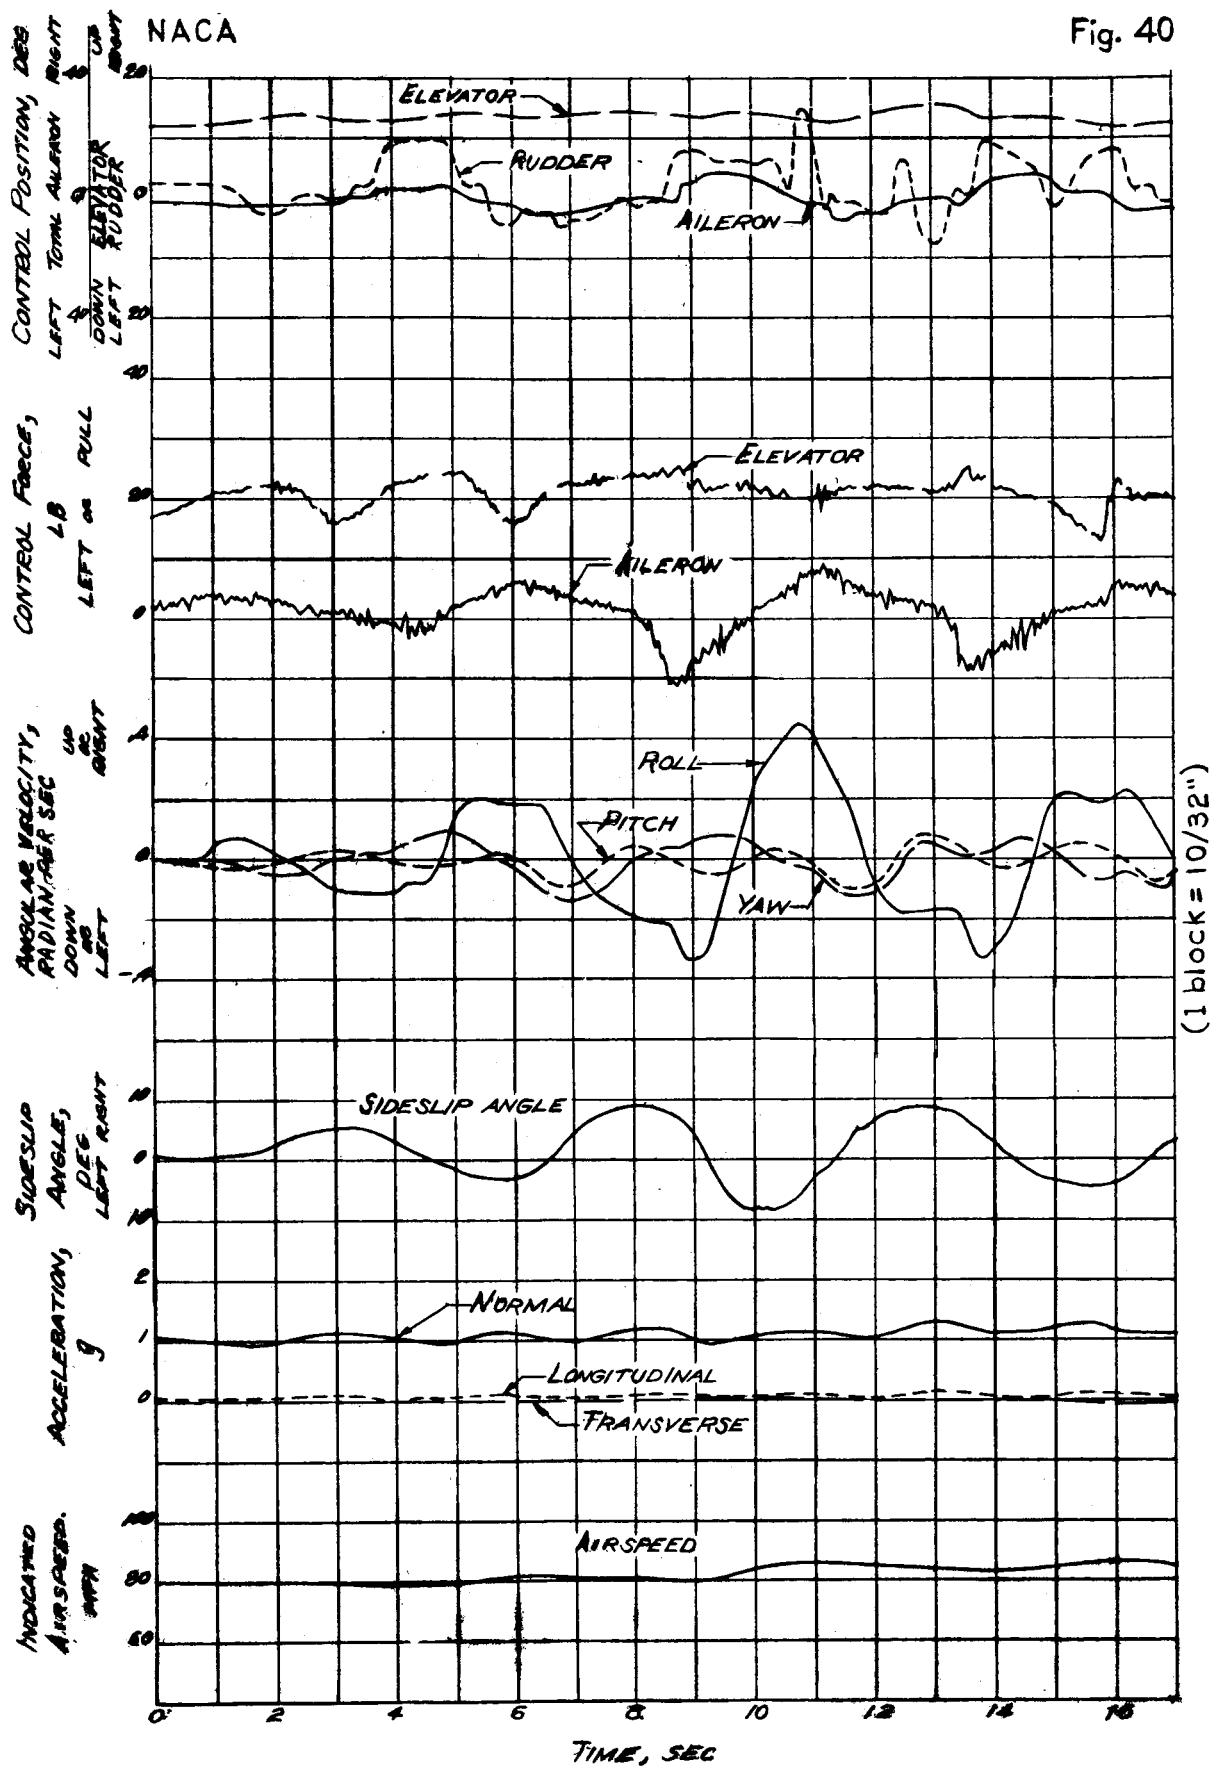
Figure 40. - Time history of a stall in the gliding condition (flaps up, gear up, power off). Control is maintained by use of the rudder. Brewster XSB-1 airplane.

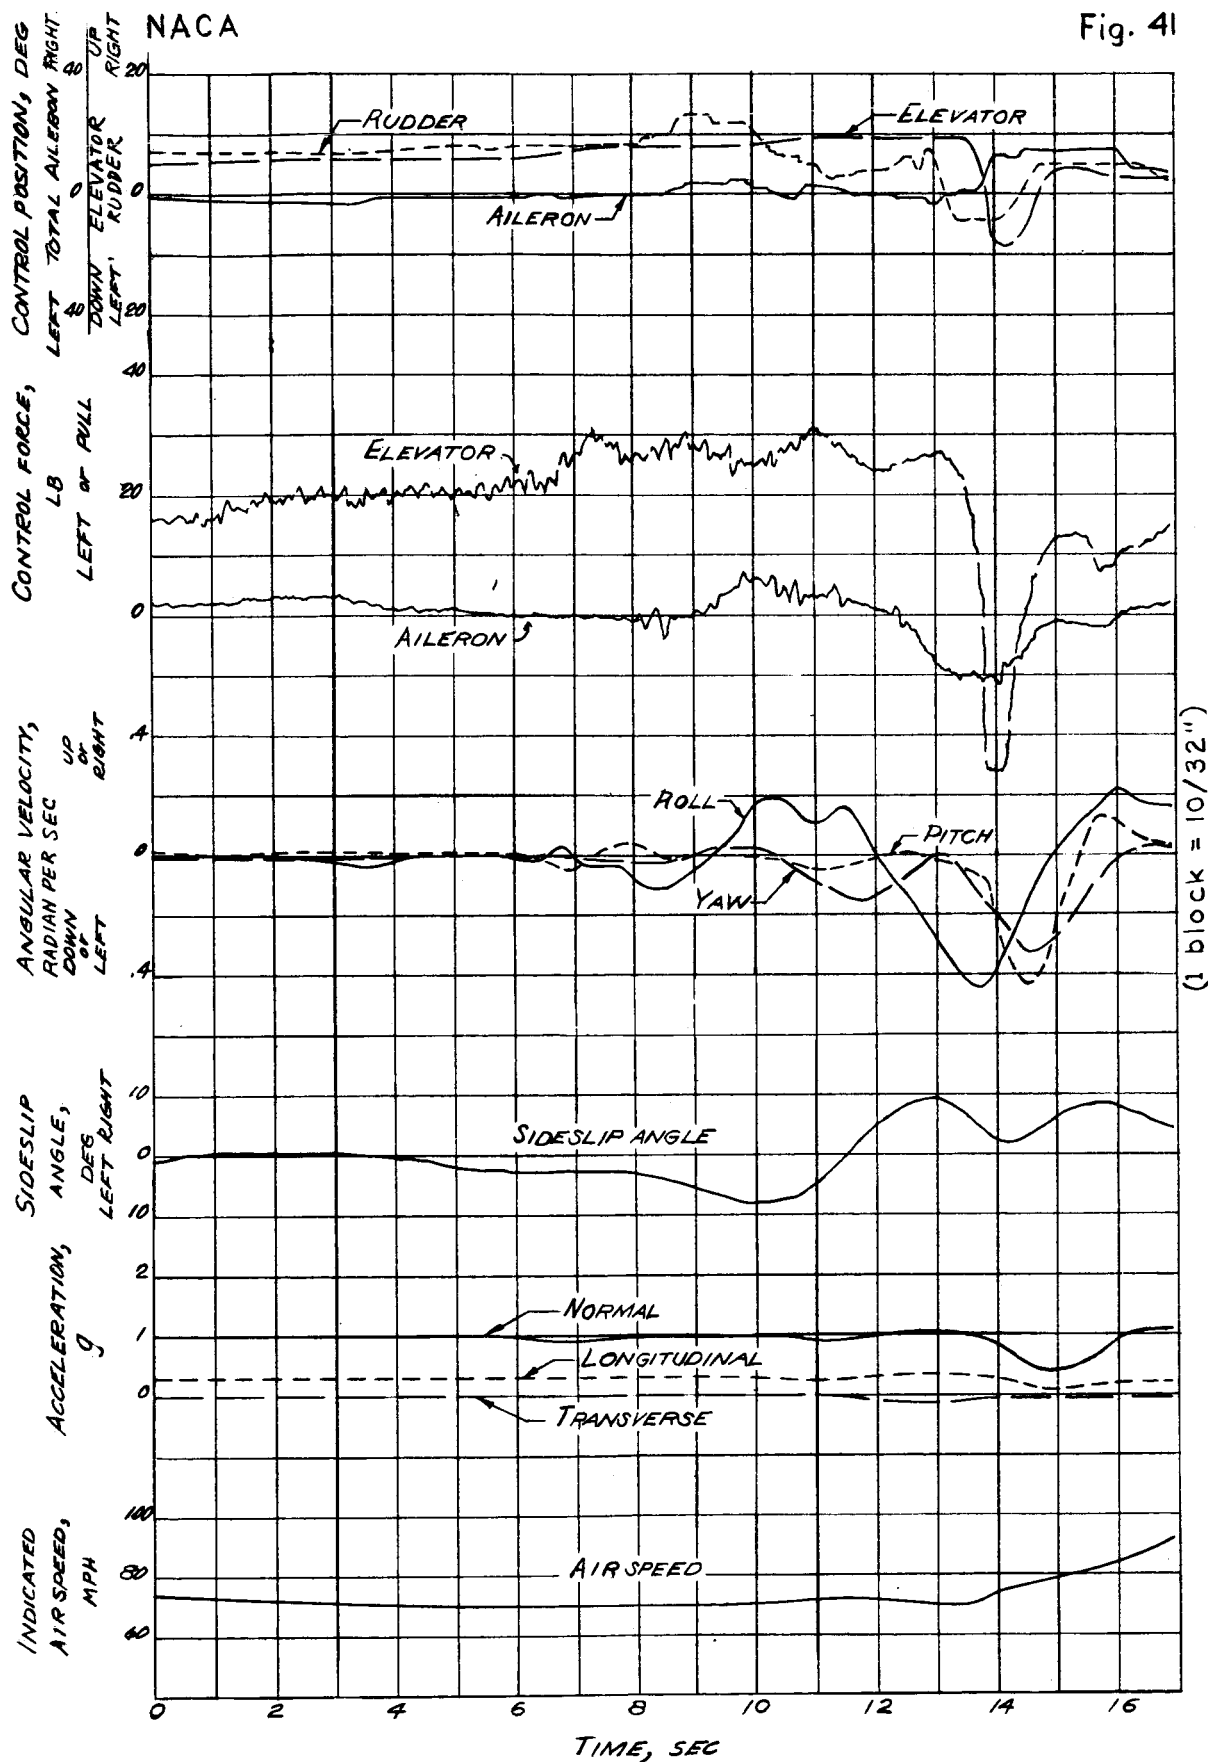
Figure 41. - Time history of a stall in the cruising condition (flaps up, gear up, 23 inches Hg manifold pressure, 1750 rpm). Control was maintained by use of rudder until roll-off to the left occurred. Brewster XSBA-1 airplane.

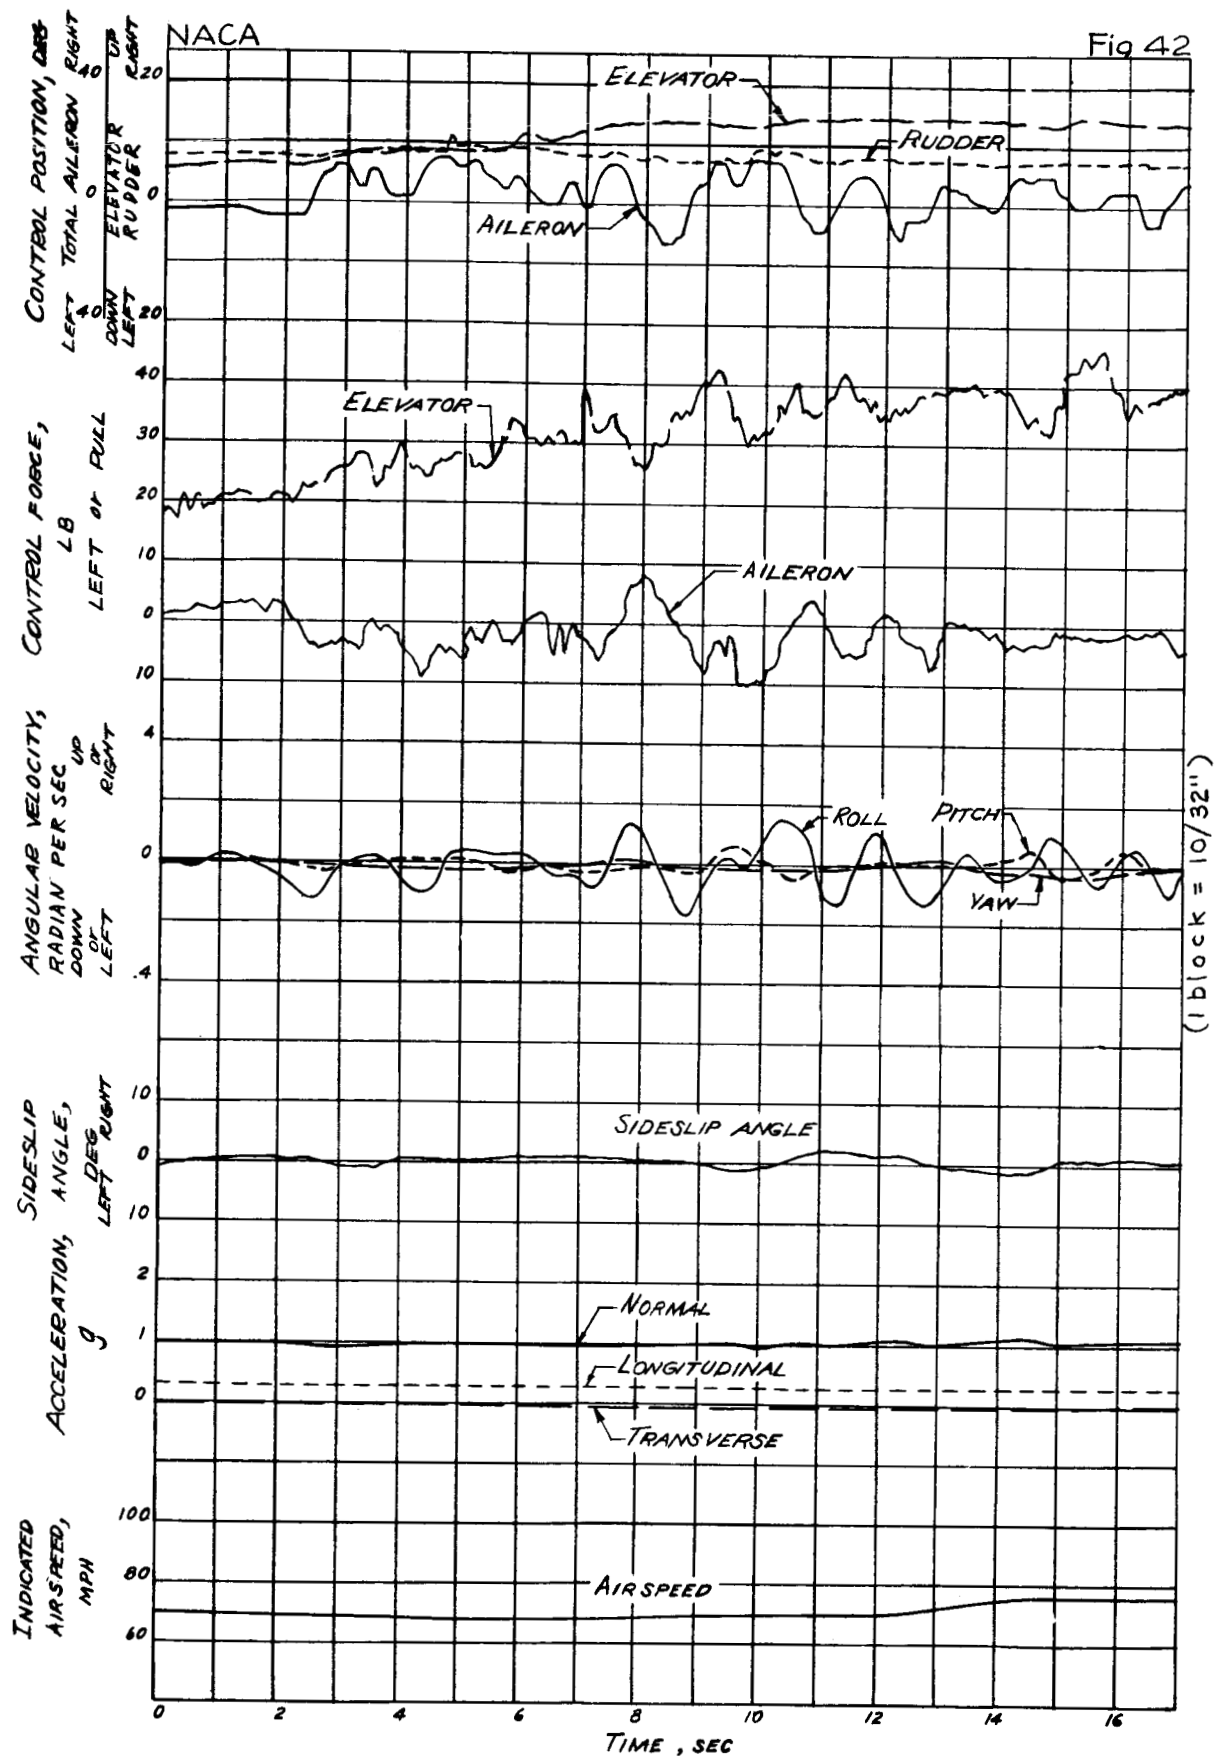
Figure 42. - Time history of a stall in the cruising condition (flaps up, gear up, 23 inches Hg manifold pressure, 1750 rpm). Control is effectively maintained by use of the ailerons. Brewster XSBA-1 airplane.

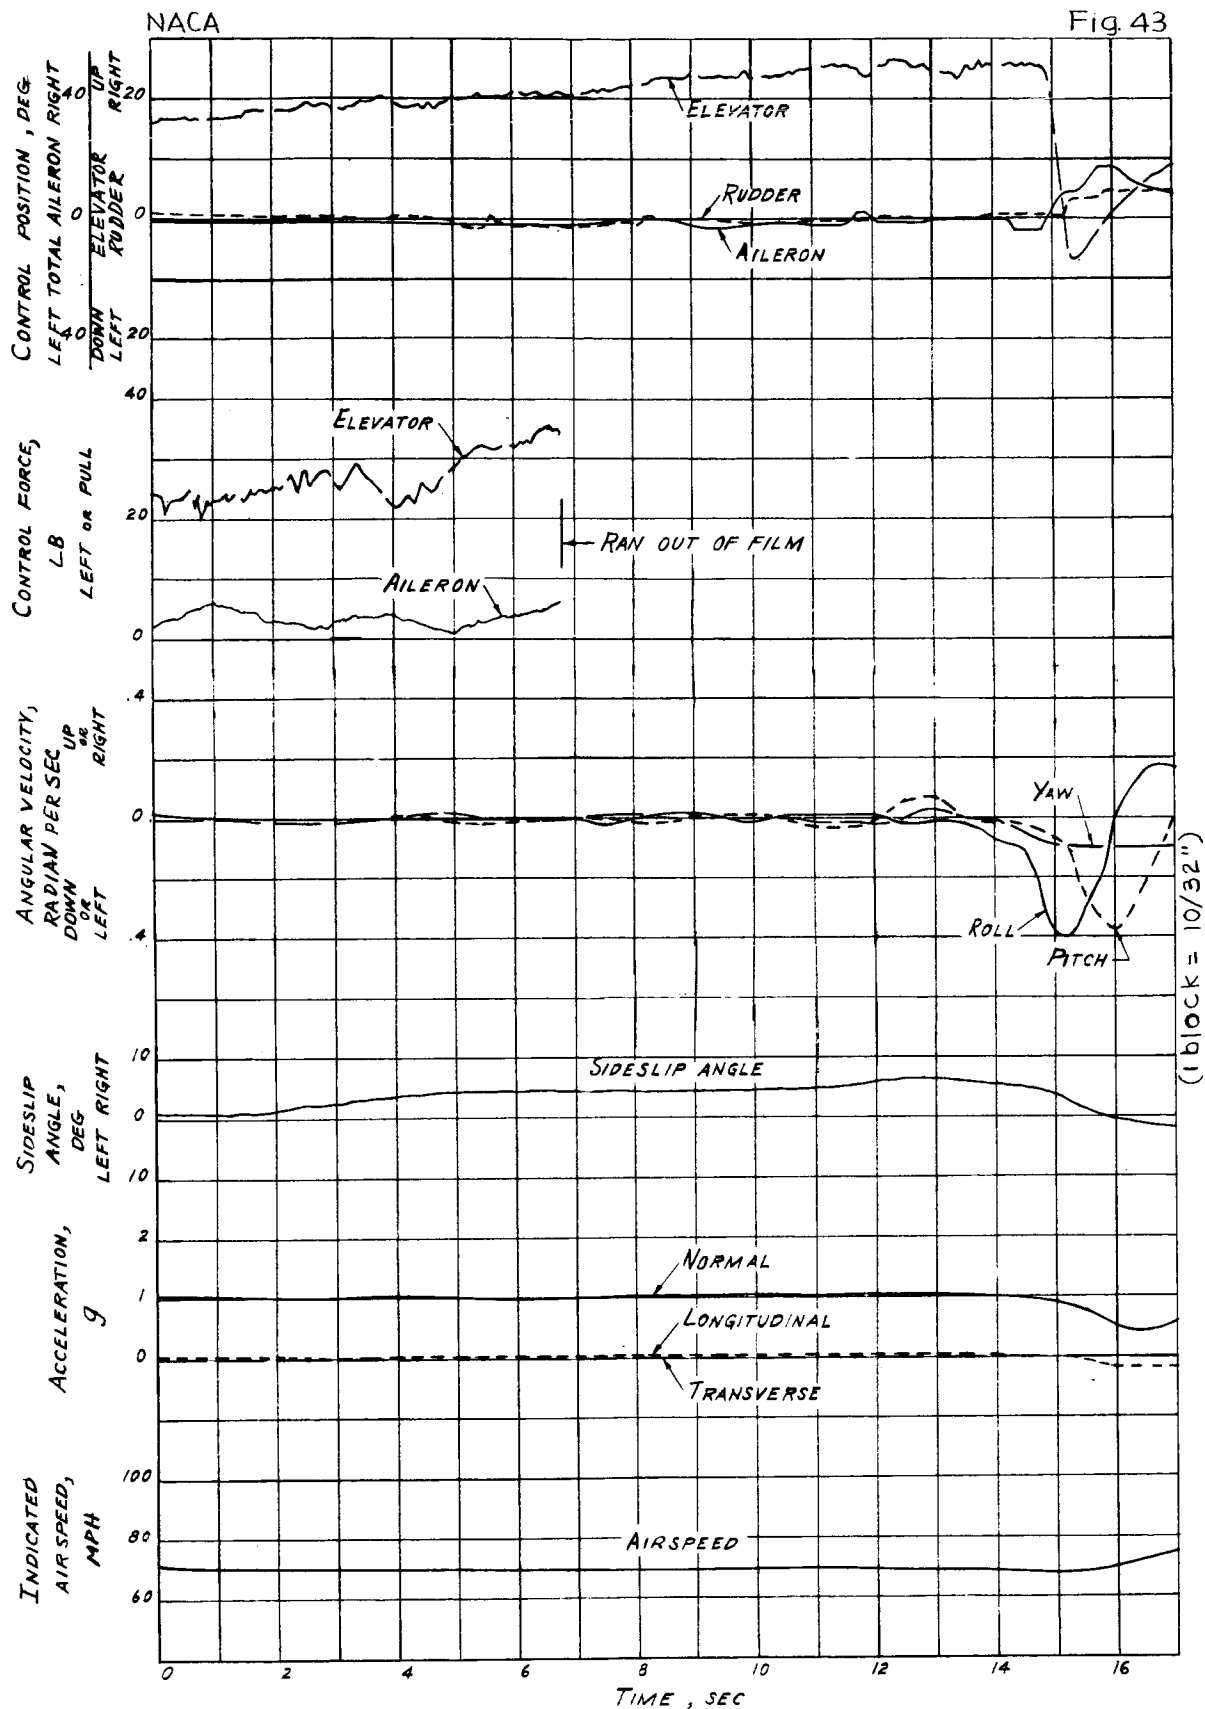
Figure 43. - Time history of a stall in the landing condition (flaps down, gear down, power off). Controls held fixed until roll-off to left occurred. Note adequate stall warning in form of slight rolling and pitching oscillations. Brewster XSBA-1 airplane.

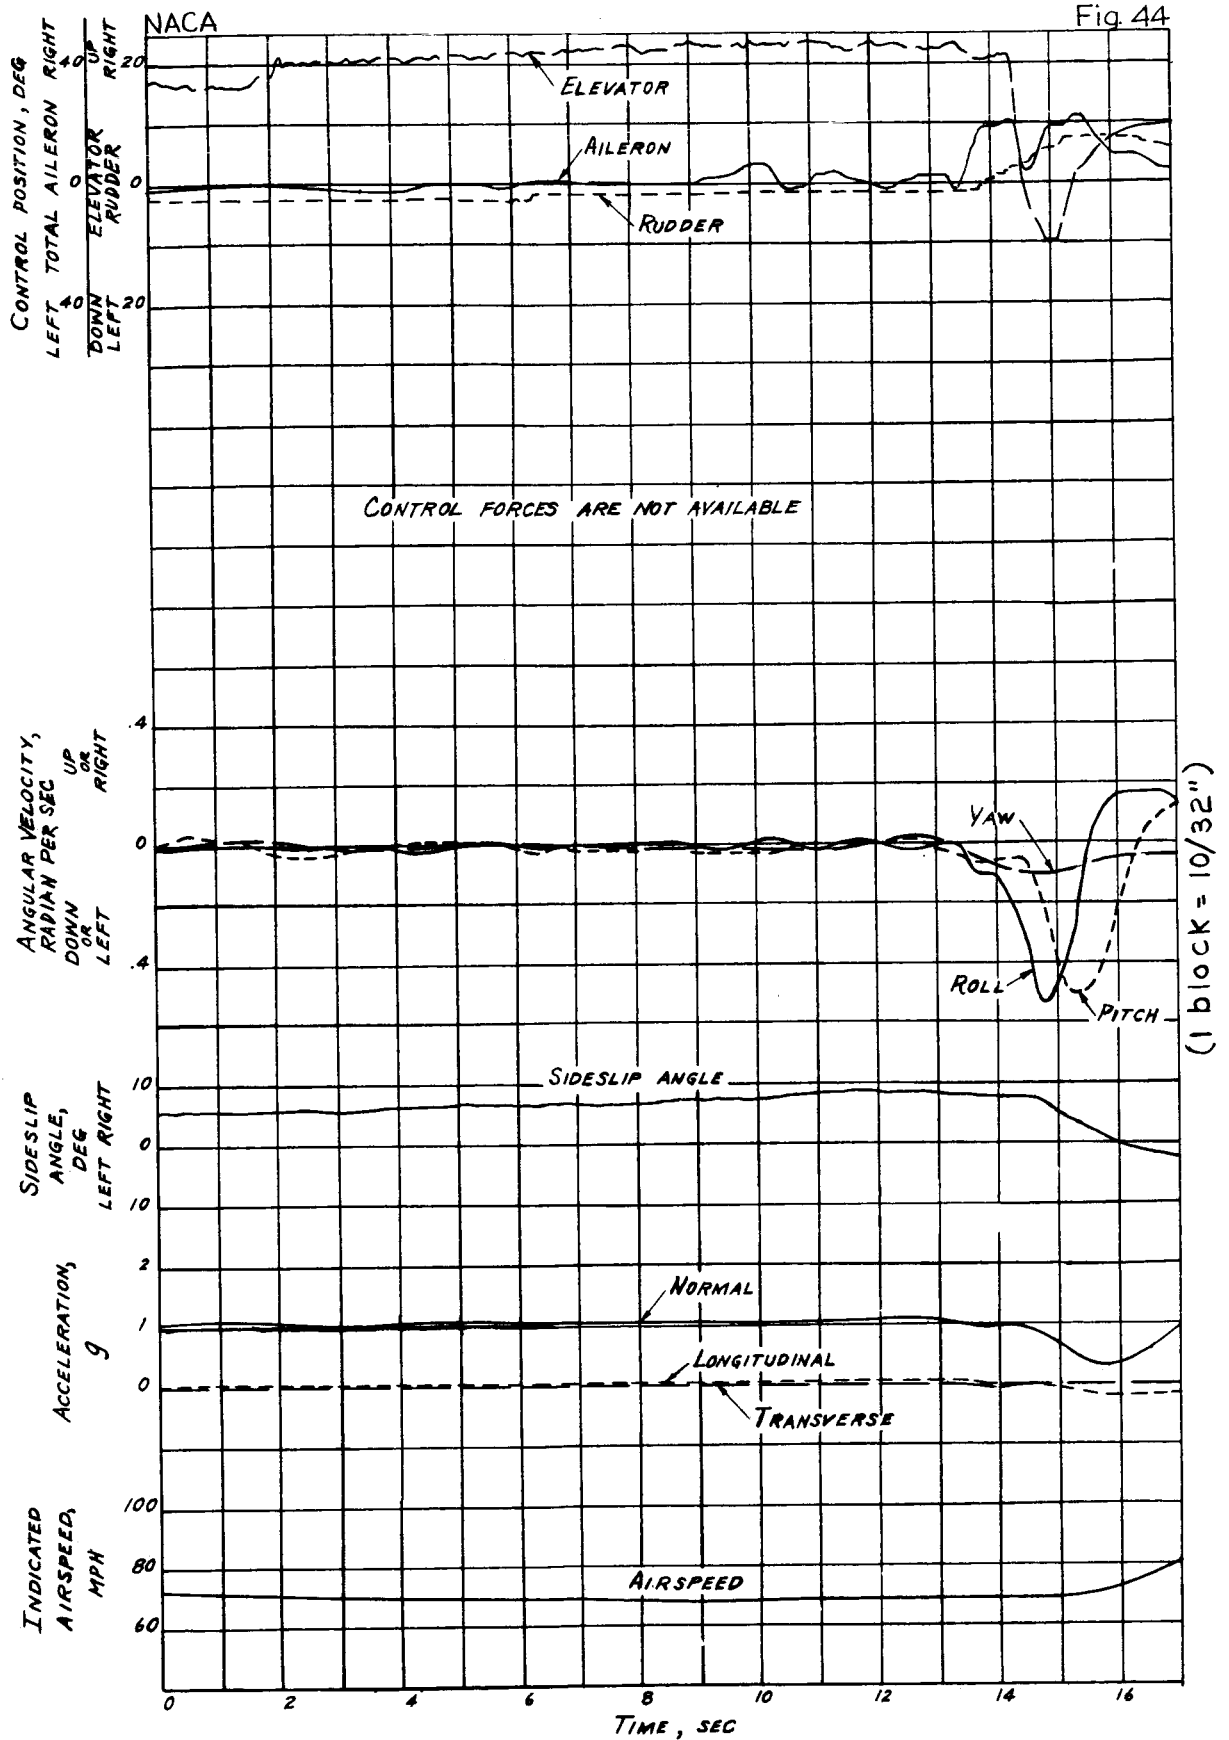
Figure 44. - Time history of a stall in the landing condition (flaps down, gear down, power off). Control attempted with aileron was ineffective in preventing roll-off to left. Brewster X3BA-1 airplane. .1
